General Motors TIS2WEB (On-Line)			
Error Message, Code or Problem	Description	Possible Cause	Solution
Access Denied	Message appears after trying to launch Console.	Tool is not powered or has timed out.	Power cycle tool (unplug ac/dc adapter or disconnect from ALDL). Retry.
Another session is running		Previous TIS2WEB session not closed out. (Also see E4212)	1. Previous flash secession not closed out after successful flash. 2. Be careful not to double click on SPS icon when launching TIS2WEB.
Error to launch SPS	Occurs after selecting START SPS and while JAVA is attempting to load	Browser settings wrong	• Reset browser defaults. Retry.
Flash2 tool may be powered incorrectly. Please correct the problem and try again.		<ul style="list-style-type: none"> • Situation: Flashing 1994 vehicle, on-car, OBD-I cable, and cigarette adaptor. • unknown cause as of 2.8.08, only single occurrence. 	1. Reboot system and retry. 2. Check and verify vehicle and vehicle information. Correct as needed and retry. Correct power configuration: <ul style="list-style-type: none"> • On-car OBD-I needs black connector ALDL cable and cigarette adaptor (no AC adaptor). • On-car OBD-II blue connector ALDL cable

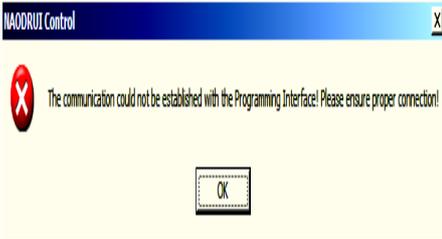
Calibration files does not exist on Disc version being used	only solution is to upgraqde to the tis2web
